# Durability performance of fiber reinforced shotcrete in aggressive environment.

J. P. Kaufmann

*Empa, Swiss Federal Laboratories for Materials Science and Technology, Laboratory for Concrete/Construction Chemistry, Duebendorf, Switzerland.*

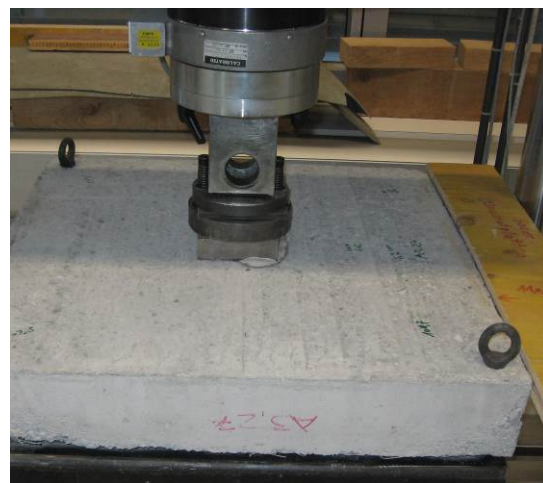
Figure 1 Crack production in interrupted EFNARC square panel test. Test was stopped at a deformation of 3 mm.

Square panel tests according to SIA 162/6 (1999) ‘Testing of steel fibre reinforced concrete’ were performed (test arrangement Figure 1). The load was applied at the center of a square panel. The deflection of the panel was measured continuously. The panel had a dimension of 600 × 600 × 100 mm<sup>3</sup>. The square support had an edge length of 500 mm and the loading rate was 1.0 mm/min. In order to reduce friction, the plates were polished parallel to achieve a roughness smaller than 1/10 mm. This test method is equivalent to EN 14488-5 (2006) and the European Specification for sprayed concrete guidelines (EFNARC, 2000) with regard to test body dimensions and load application. The absorption of energy (in joules) is determined, in accordance with the directive EFNARC (and EN 14488-5) by integration of the load–deflection curve to a deflection of 25 mm as it is defined in this standard. It should be emphasized that this is in contrast to ASTM C 1550 round panel test, where a larger deflection of 40 mm is applied.

The durability experiments were carried out in a cracked state. Initial crack widths corresponding to the state of use were generated in an interrupted square panel test (SIA 162/6). At the age of approximately 120 days, the test panels ( $600 \times 600 \times 100 \text{ mm}^3$ ) were loaded, while regulating the expansion, until a deflection of  $\delta = 3 \text{ mm}$  was achieved and then unloaded in controlled manner immediately after reaching this limit. Four to six cracks (according the mechanical performance of the fiber introduction) crossing the square panels were introduced. Crack widths were typically in the range of 0.5 to 1 mm at a distance of 15 cm from the center and about 2 mm at the center of the square panels. The panels then were exposed to different storage conditions.

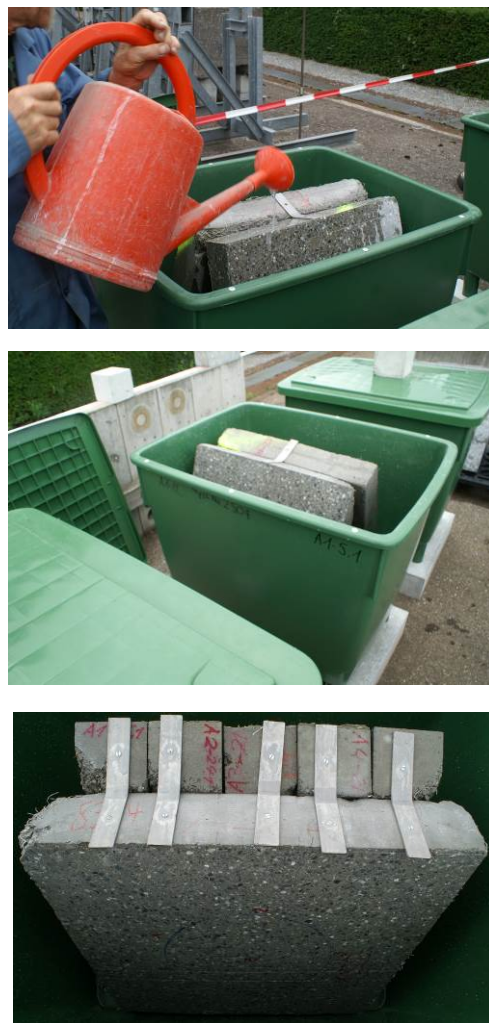
Figure 2 Exposure set-up with application of liquid solutions (top), coverage (center) and different specimens (square panels for mechanical testing and prisms for microscopy, bottom).

Square panels and prisms were exposed to the storage conditions according Table 3. They were placed in large containers, one specimen for each kind of shotcrete for each storage condition. Some of the cracked specimens were stored (with introduced cracks) in a climate chamber at  $20^\circ\text{C}/90\%\text{RH}$  (storage 1), others were exposed to the current weather in northern Switzerland (storage 2) and to different solutions. Each specimen was rinsed with five liters of one of the three solutions (always the same) once per week during 1 year. Some of the solution was collected at the bottom of the container and used for rinsing each second time, the other times the solutions were freshly prepared. The filling level of the solutions in the container was not achieving a level to touch the specimens. The containers were covered (except storage 2).

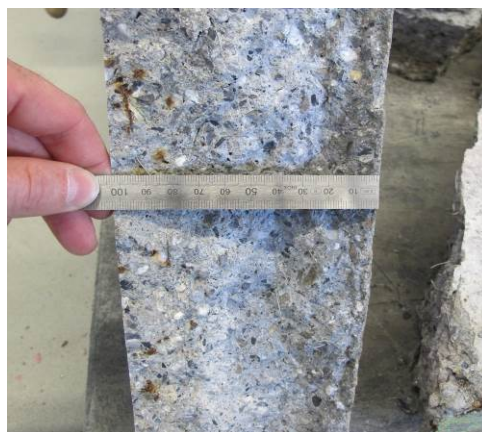
Figure 8 Photo of steel fiber reinforced square panel (A1) after 1 year of exposure to Salt (NaCl)-solution (3%) after square panel testing.

The reason for the drop of the mechanical properties for steel fiber reinforced shotcrete is obviously corrosion which can easily be observed on all steel fiber reinforced panels (also storage 1). This is visualized in Figures 7 and 8. Corrosion has not proceeded to the same degree throughout the crack, but is reduced with longer distance from the surface. This was especially the case when the exposure was to a sodium chloride solution (Figure 8).

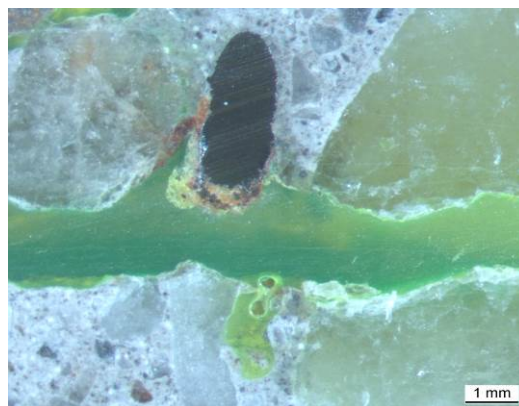
Figure 9 Micrograph of steel fiber near cracks (impregnated for conservation with green resin) at a distance of 35 mm from surface after 1 year exposure in  $\text{Na}_2\text{SO}_4$ -solution (A1).

This is confirmed by the microscopic analysis of the pre-cracked prism specimens. While corrosion traces in the case of steel fibers close to the cracks are obvious (Figure 9), no visible deterioration of polymer fibers is observed (Figure 10).

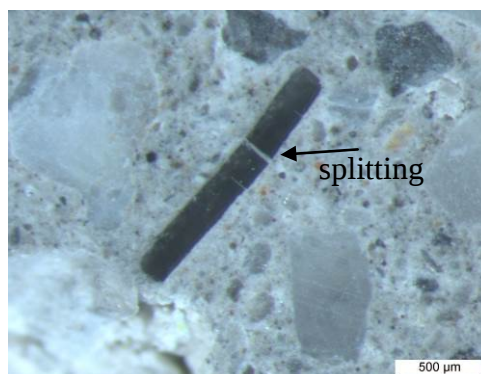
Polymer fiber (A2)

Polymer fiber (A3)

Polymer fiber (A4)

Polymer fiber (A5)

Figure 12 Typical Micrographs of fibers in undamaged shotcrete (storage 3).

Some polymer fibers on the other hand may suffer from damage originating from high pump and spray pressures and hence increased shear forces acting on the fibers during the shotcrete preparation and application. Fibers may fissure or even split completely (polymer fiber A5) along their length (arrows in Figure 12). Figure 12 clearly shows ruptured polymer fibers which are not situated close to a crack. As the ruptured part is filled with cement products, rupture was due to the application (spray) process and not due to mechanical loading of the shotcrete (during pre-cracking for instance). Such rupture, which is along the fibers, however is not critical when the bonding to the shotcrete matrix remains intact.
