# Durability performance of bi-component polymer fibres under creep and in aggressive environments

## Abstract

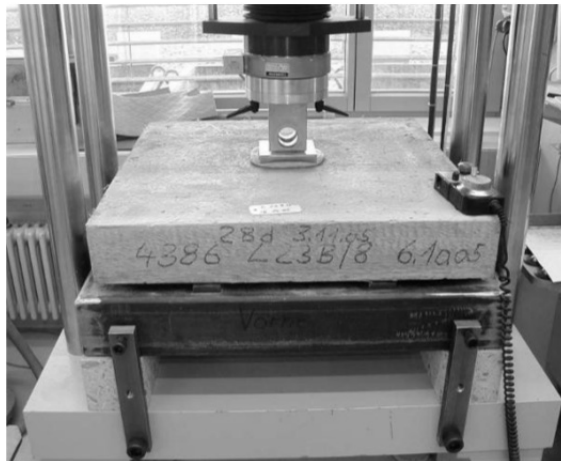
**Figure 1** Test arrangement in square panel tests according to SIA 162/6

Square panel tests according to SIA 162/6 (1999) 'Testing of steel fibre reinforced concrete' were performed (Figure 1). This praxis-oriented test is especially suitable for characterising the behaviour of fibre

reinforced concrete in tunnel linings or industrial floors under local pressures. The load in this test was applied at the centre of a square panel. The deflection of the panel was measured continuously. The panel had a dimension of  $600 \times 600 \times 100 \text{ mm}^3$ . The square support had an edge length of 500 mm and the loading rate was 1.0 mm/min. In order to reduce friction, the plates were polished parallel to achieve a roughness smaller than 1/100 mm. This test method is equivalent to EN 14488-5 (2006) and the European Specification for sprayed concrete guidelines (EFNARC, 2000) with regard to test body dimensions and load application. In addition to those tests, the calculated value of the effective flexural strength  $f_{ctf}$  is derived as:

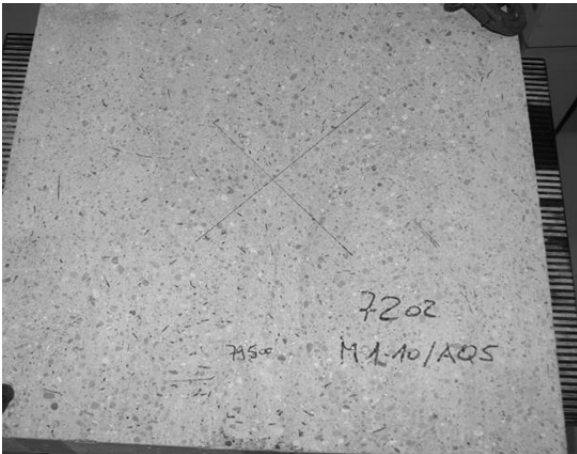
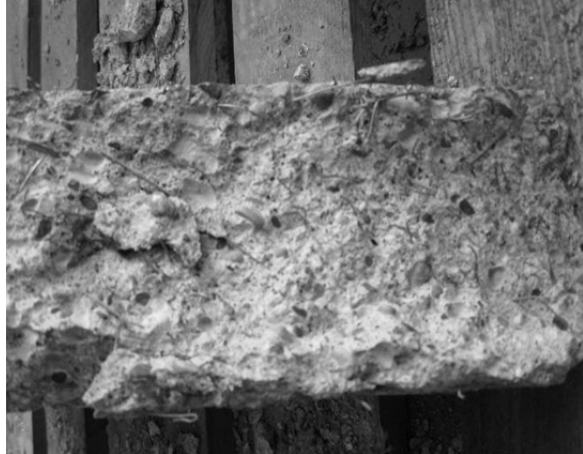
Free weathering: steel fibres => some fibre corrosion (mostly close to the surface)

**Figure 6 Detailed views of the different panels containing steel or polymeric fibres subjected to different environments after one year of exposure**

After one year of exposure all of the steel fibre reinforced concrete panels, even the ones stored in the climate chamber and subjected to free weathering, showed clear signs of corrosion on the concrete surface (Figure 6). These range from clearly visible rust spots (particularly evident for an exposure in a NaCl solution) up to complete dissolution of the fibres in the case of an exposure to a low concentrated sulphuric acid. In contrast, there was no visible alteration observable for the panels made with polymeric fibres.

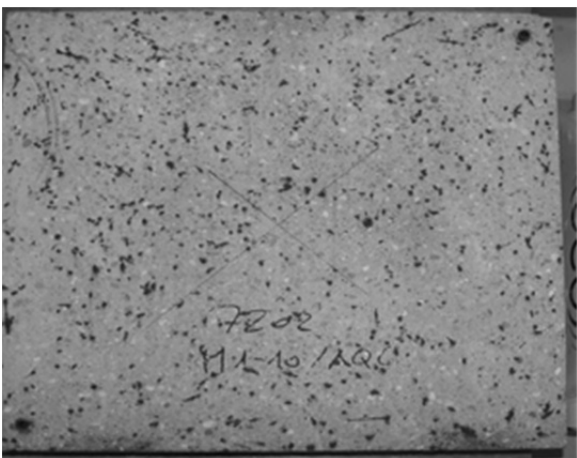
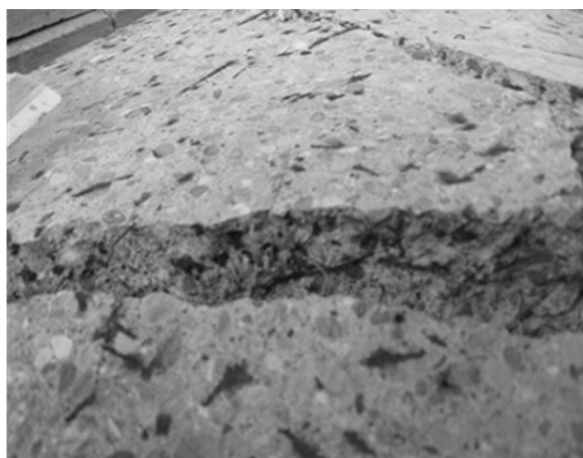
3% NaCl solution: steel fibres => very strong fibre corrosion (also inside the cracks)
